**Photos Showing Current Condition
of the
Brick Tavern Museum of the Schuyler County Historical Society**

Roofing Issues of the Brick Tavern Museum

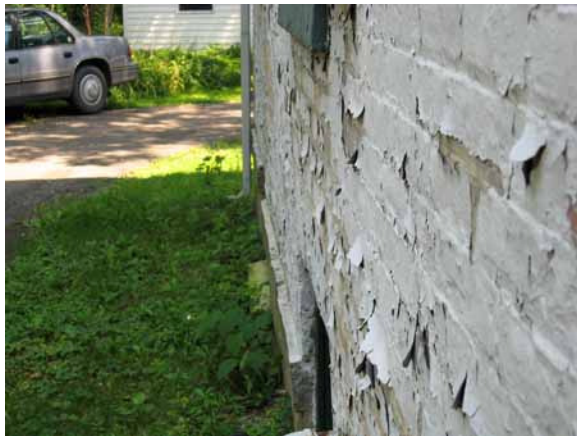
Typical wall condition of Museum.

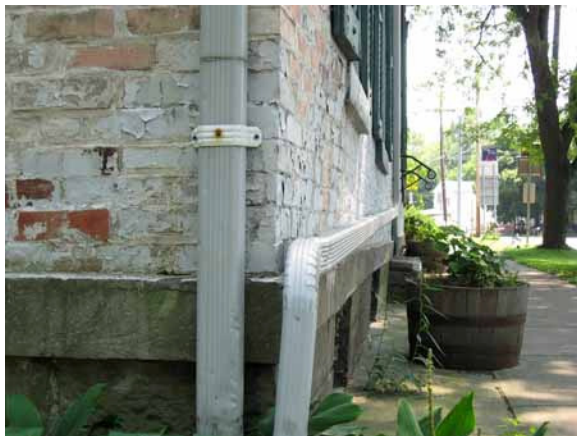
View down front sidewalk.

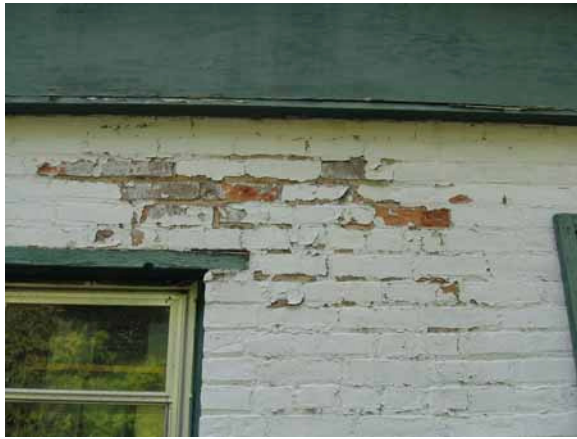
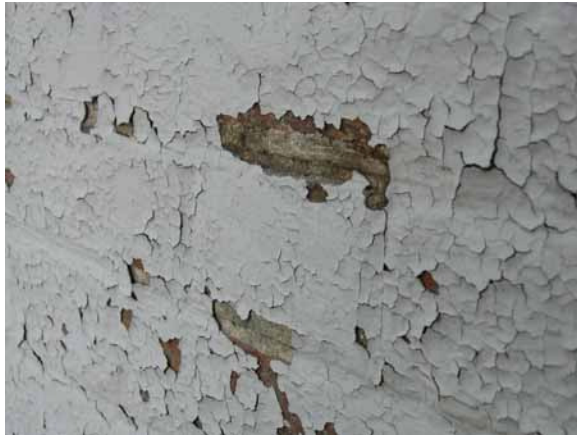
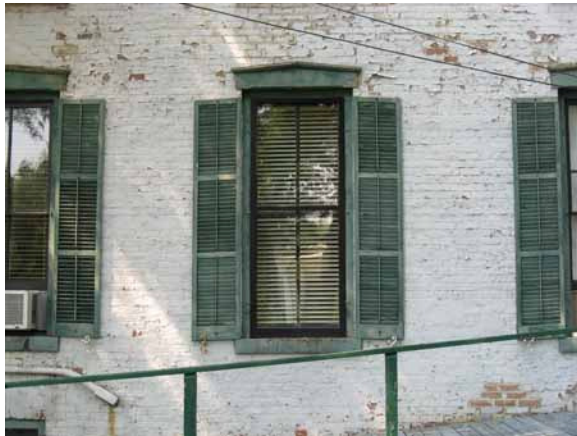
Typical wall conditions.

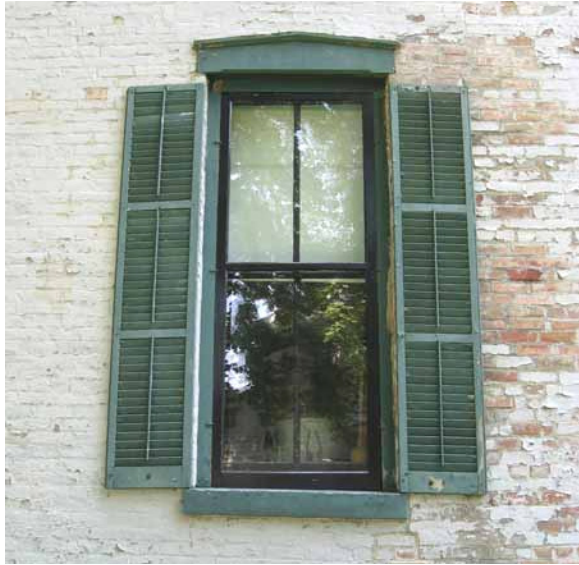
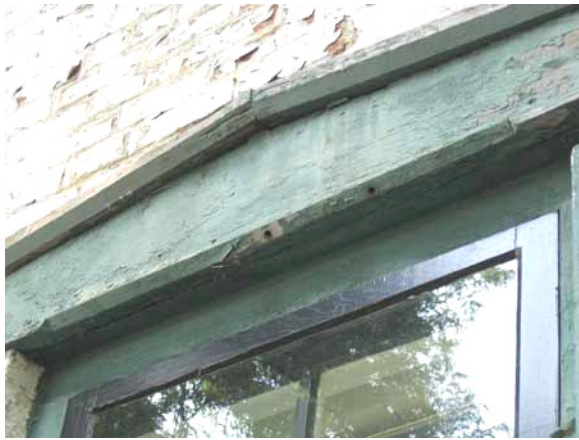
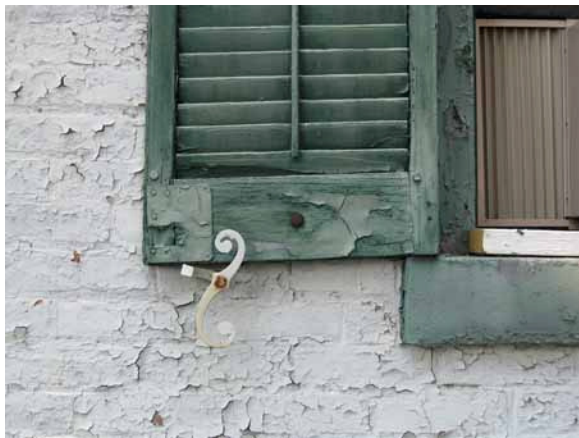
Condition of historic shutters

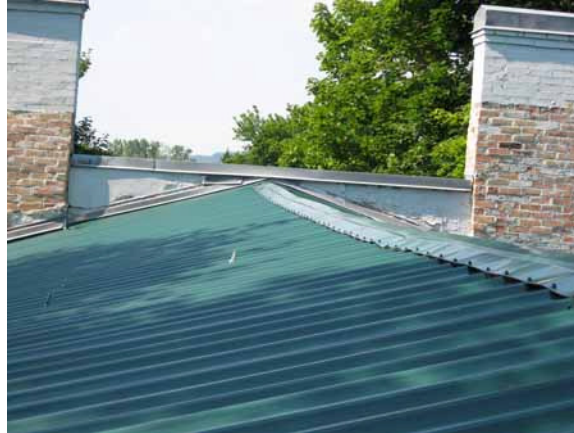
Main roof looking northeast. Note sag in ridge.

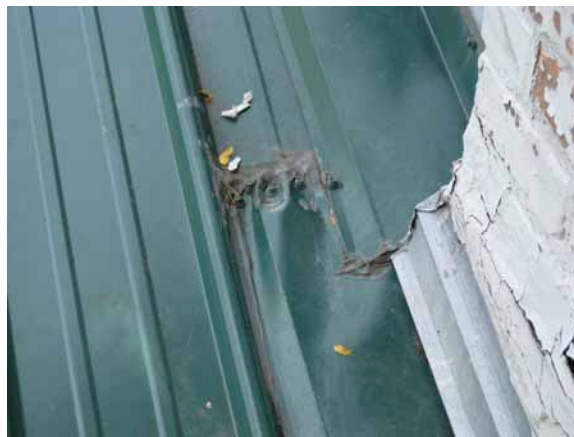
Dependence on short-lived tar for waterproofing at exposed fasteners.

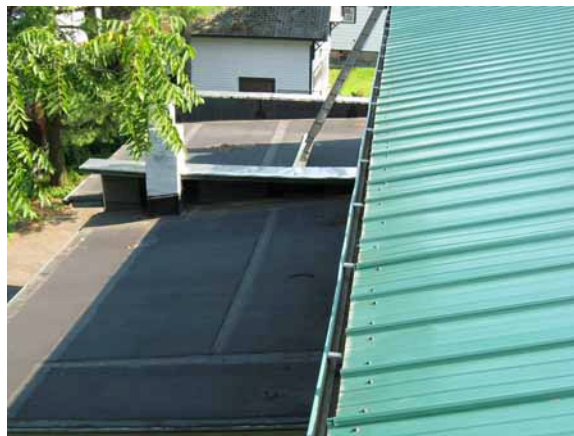
Membrane roofing at porch and southeast addition.

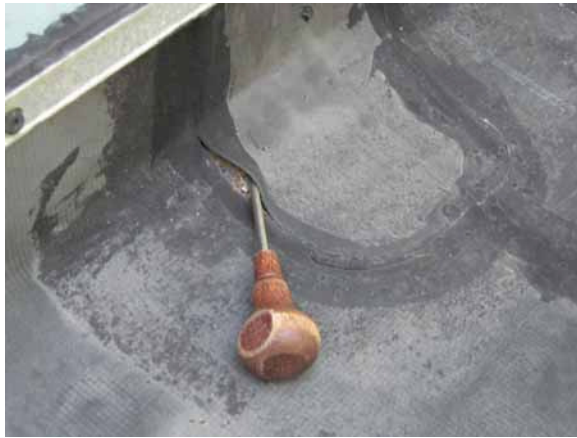
Typical open seam at membrane roofing.

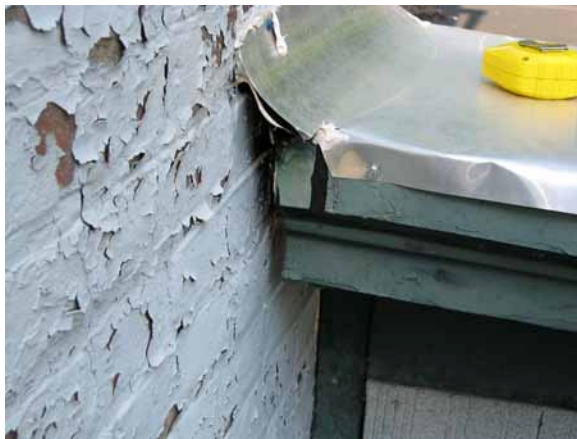
Light-gauge coping cover. Note tear in aluminum at bend and lack of counter flashing.

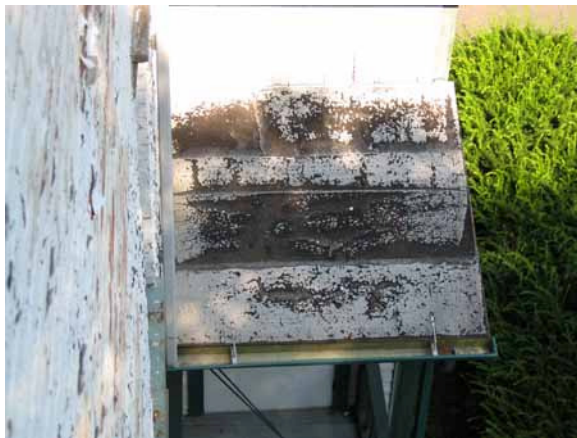
Worn out South porch roofing.
